Neutral Citation Number: [2025] EWHC 721 (Admiralty)

**IN THE HIGH COURT OF JUSTICE**  
**BUSINESS AND PROPERTY COURTS**  
**OF ENGLAND AND WALES**  
**KING'S BENCH DIVISION**  
**ADMIRALTY COURT**

**THE OWNERS OF THE "X-PRESS MAHANADA"**

**THE OWNERS OF THE "BURGAN"**

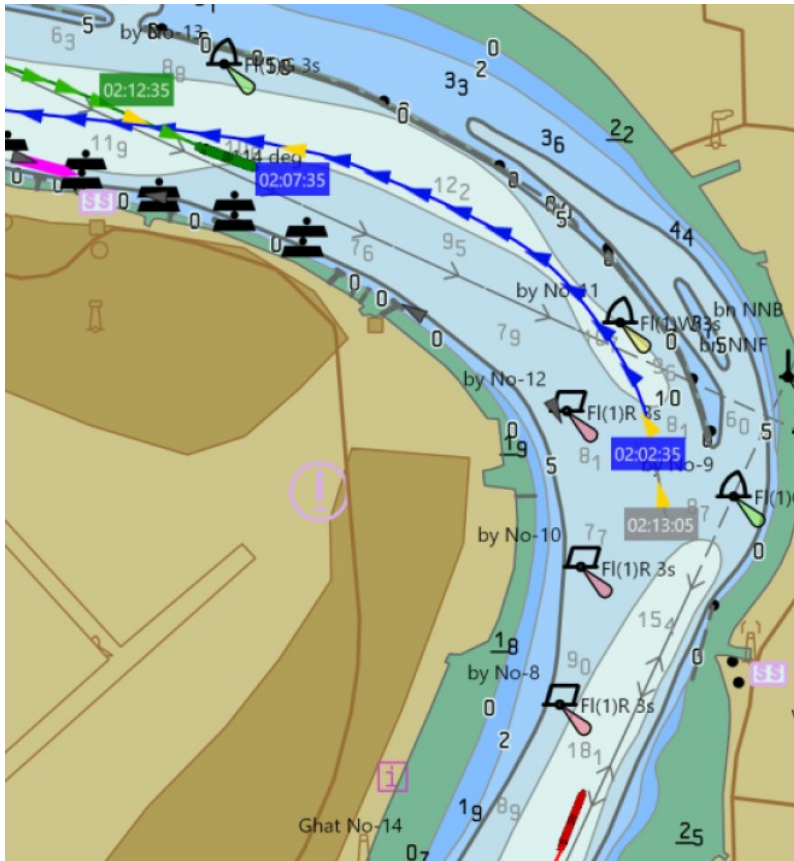
44. 0813:59 BURGAN's pilot said "*It seems to be an army ship, no communication. They don't know how to communicate, how to operate*".
45. In the chart below XPM can be seen in red at the bottom right. SS is in light grey.

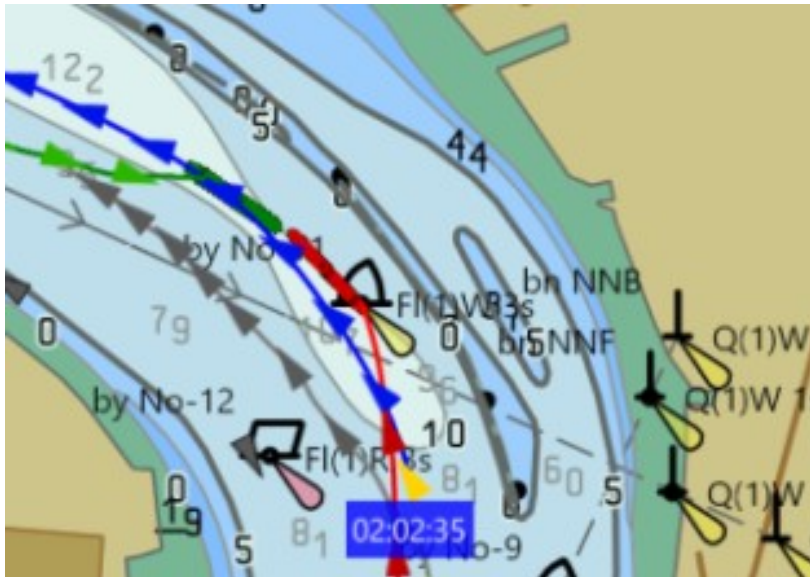
68. Very shortly before collision, at 0817:26 the engine of XPM was put to stop and her rudder was put hard to starboard.
69. The XPM and BURGAN collided at the Gupta Crossing at about 0817:35 in a position well to XPM's starboard side of the river at the very edge of the buoyed channel. The collision was almost head on, with the port bow of XPM colliding with the starboard bow of BURGAN. The XPM was heading about 316° at collision and the BURGAN about 125°. The XPM was making about 13.3 knots over the ground (10.3 knots

through the water) and the BURGAN was making about 7.7 knots over the ground (10.7 knots through the water).

70. The respective positions of the vessels appear below:
