Neutral Citation Number: [2025] EWHC 721 (Admiralty)

**IN THE HIGH COURT OF JUSTICE**  
**BUSINESS AND PROPERTY COURTS**  
**OF ENGLAND AND WALES**  
**KING'S BENCH DIVISION**  
**ADMIRALTY COURT**

**THE OWNERS OF THE "X-PRESS MAHANADA"**

**THE OWNERS OF THE "BURGAN"**

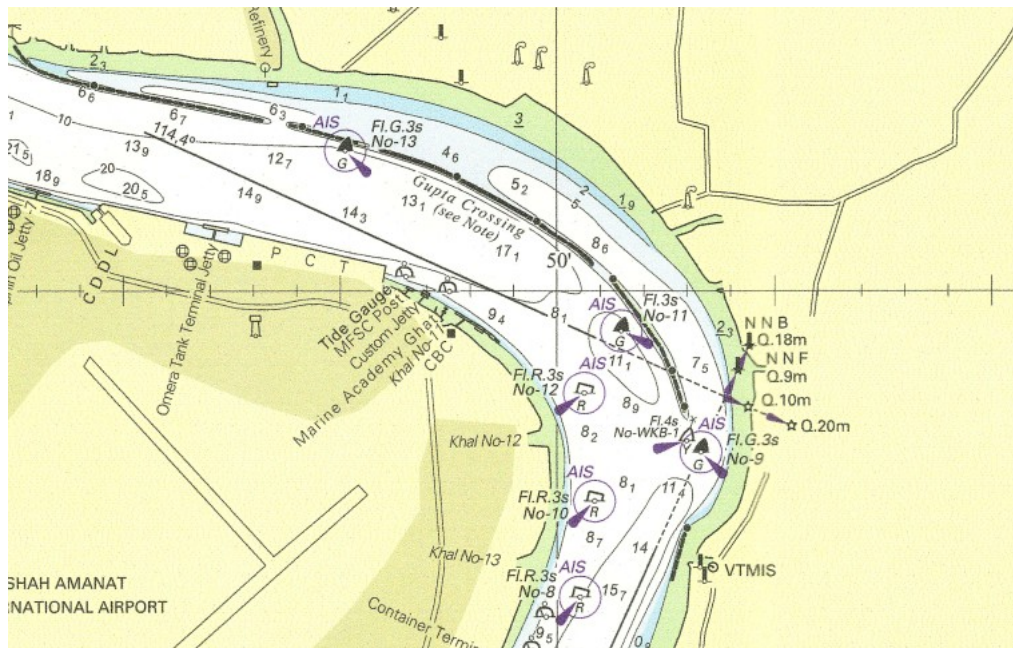
24. To mark the navigable limits there are a series of physical buoys. In particular at the NE of the bend, in front of the wall is Buoy 11. The Admiralty chart 102 also has a heading of 114.4° marked. The purpose of this is unclear. It involves a heading well to the port of the line indicated by the Col Regs; if followed it actually positions a vessel to the port of the channel as the restraining wall comes to an end and the bend is negotiated. However it does take a line which (i) positions a vessel safely north of floating mooring buoys and some indications of shallower water (ii) effectively keeps a vessel within the very deepest part of the river and (iii) permits a simple turn close to Buoy 11 bringing the vessel almost due south towards the starboard side of the river once the bend is passed. It may therefore be regarded as an ideal course to take if there were no other vessels to take into account.

25. BURGAN's course appears to have been originally plotted to take her to acquire this 114.4° heading marked on the chart. This appears to have been the course taken by the vessel exiting the port immediately before her.
26. Buoy 12 is to the south west side of the river, with Buoy 10 slightly southeast of it in the north east facing part of the river. Buoy 9 is approximately at the farthest east part of the Gupta Crossing, just below the end of the training wall.

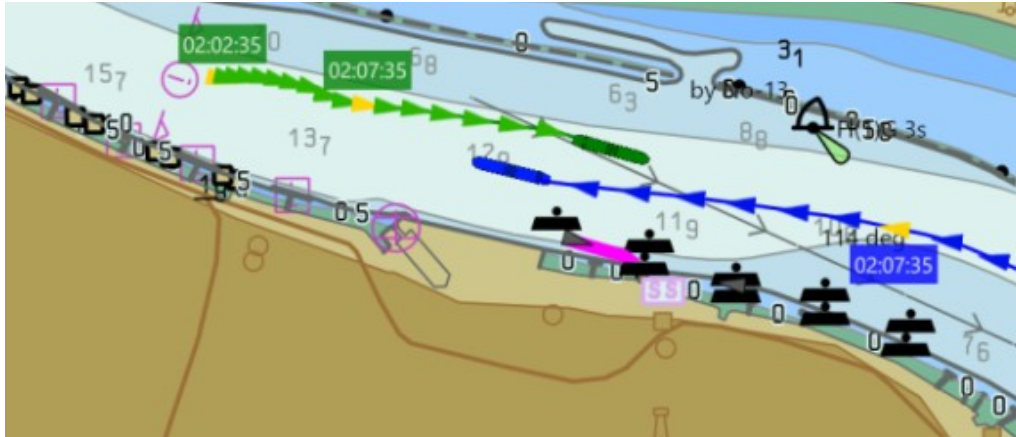
31. BURGAN and DONG JIANG were passing each other starboard to starboard at about 0810:33.
32. The inevitable result of that manoeuvre was that BURGAN was now on her port side of the river; specifically she was on a heading of 104° and making a speed of 6 knots SOG. Shortly after 0810:05 (C-7½), BURGAN altered course to starboard by about 15° for the next 2 - 3 minutes or so before steadying onto a bearing of 110°. This brought her up parallel to her original planned course but slightly to the north (and port side of the river) to it. From 0811 as she moved past DONG JIANG, BURGAN was to the port side of the centre of the channel, north of her originally planned course and nowhere near the starboard side of the river.

33. Although it was suggested in submissions that BURGAN had “steadied” on this course parallel to her original court after and in response to the emergence of the SS, the plots show different; she “steadied” roughly parallel to (but on the port side of) her plotted course immediately after clearing DONG JIANG.
34. In the chart below BURGAN is marked in green, with DONG JIANG in blue. The mooring buoys appear as black marks at the bottom of the picture.

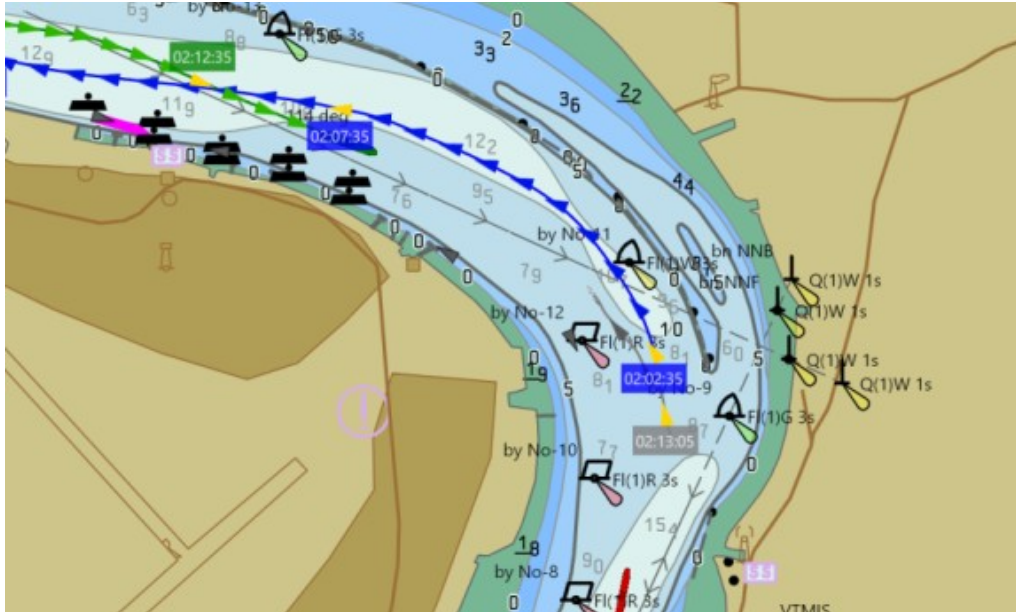
49. Nor was she *"moving gracefully ... across to the starboard side of the river"*; as noted above she had ceased to move starboard relative to the line of the 114° heading some time before. There was no sign of her moving further to the starboard side of the river.

50. SS had slowed from 10.1 knots SOG at C-3.5 to 8.7 knots at C-3.
51. By this point 3 minutes had passed since BURGAN had passed DONG JIANG.

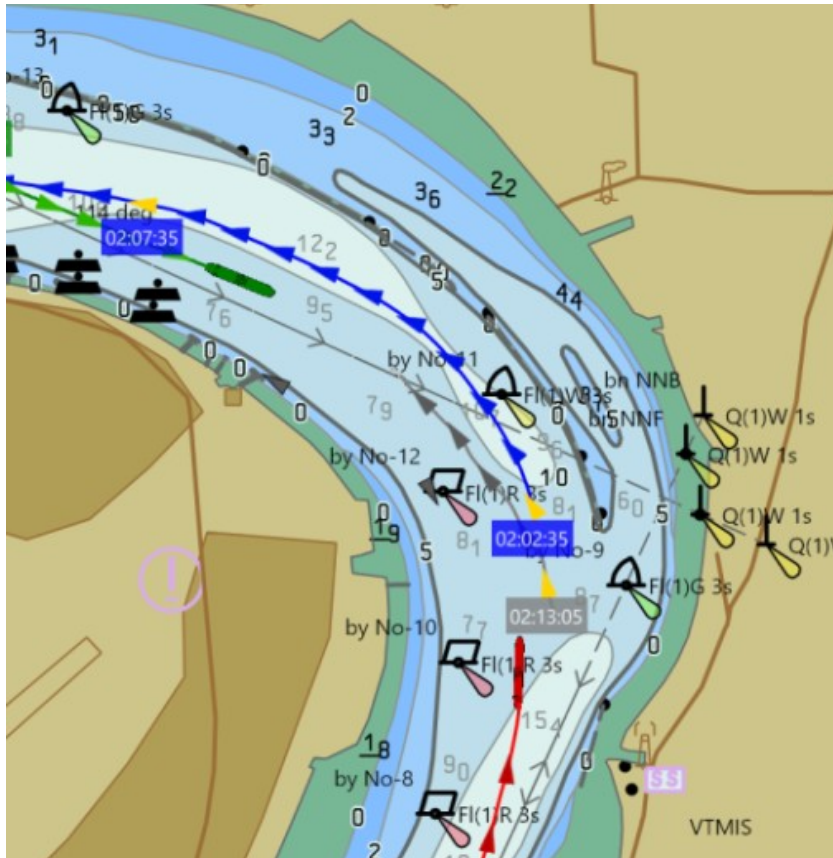
54. At 0815:21 BURGAN's pilot says *"Navy ship, increase your speed and pass quickly. Increase your speed"*. BURGAN is still heading straight for Buoy No.11, at a speed of 7.6 knots SOG (10.6 knots speed through the water) on a course of 111.8°. At 0815:31 it can be seen from BURGAN's X-Band that SS was acquired as a target a range of 0.270 miles and an eta 0817.

55. Meanwhile on board the XPM the focus was on navigating the turn. BURGAN says XPM did not see BURGAN and SS until now. In a reverse of BURGAN's situation, at this point XPM was still steering to port relative to the bank to her starboard, but because of the dogleg effect of the starboard part of the curve, she was heading to the starboard side of Buoy 11 – i.e. coming in for a tight turn to conclude on the far starboard side of the channel beyond Buoy 11.

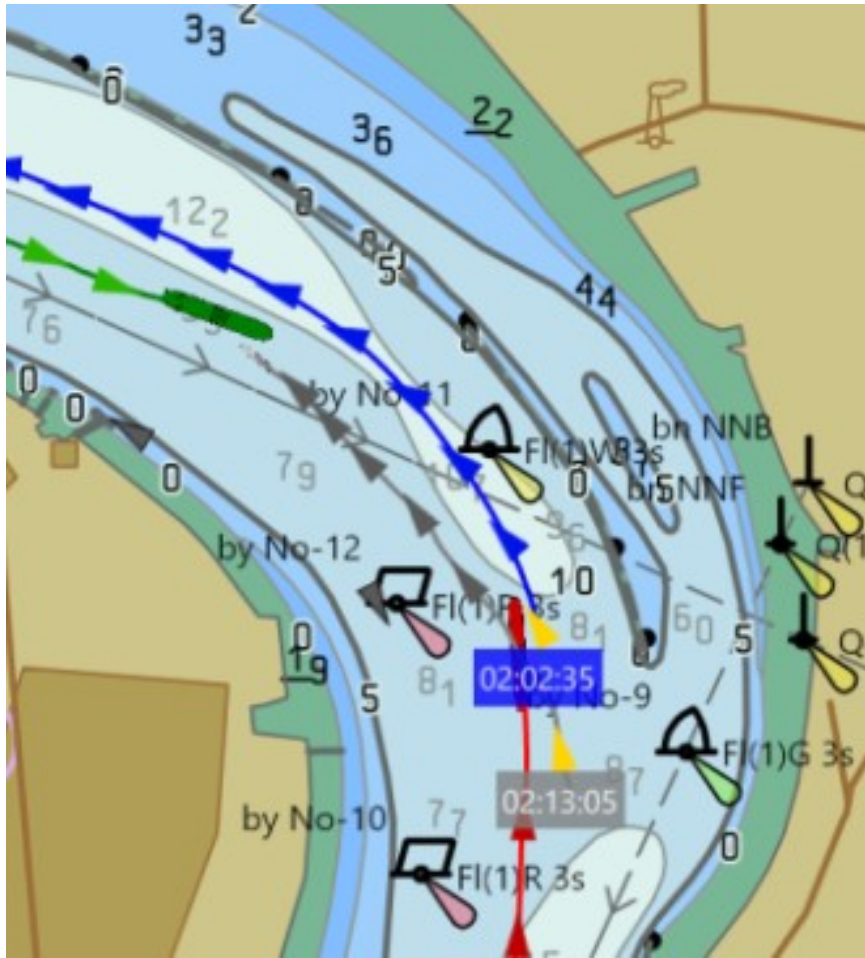
56. At 0815:41 the BURGAN's Pilot says "*Navy Ship, you move to the left. Army Ship, you go to the left*".
57. At 0815:47 the Pilot of XPM ordered her engines to be put to Full Ahead in order to assist the turn in the following tide.
58. At 0815:48 the pilot of BURGAN ordered his vessel to steer "Mid Ship" and very slightly increased speed. At 0815:50 he advised the pilot of XPM to proceed with caution.

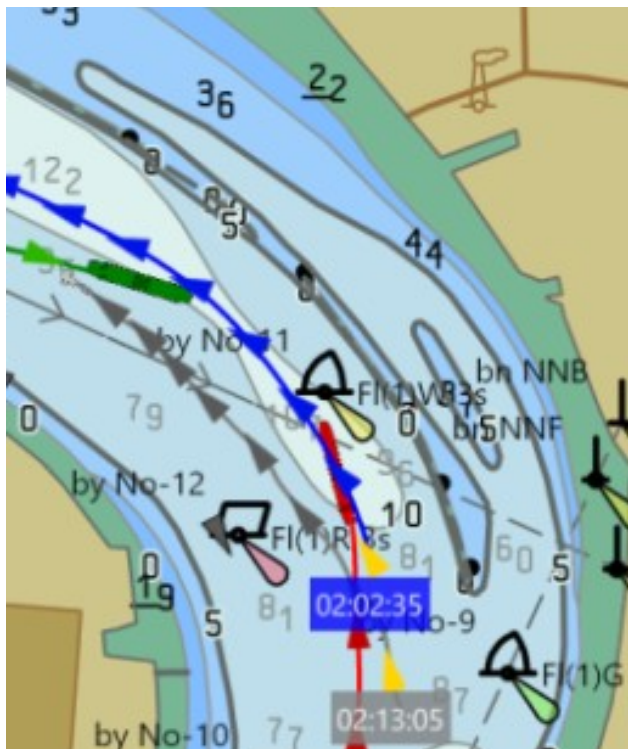
64. At 0816:30, as XPM was approaching Buoy No.11, her pilot ordered "Port 20" and she started to swing to port, following the starboard side of the river channel. There was insufficient room to starboard for XPM to pass BURGAN port to port, and at 0816:40 (C-0:55) her Pilot called BURGAN by VHF and told the Pilot of BURGAN that he was coming hard to port and told her to "*Give Hard Starboard, Kayser, Hard Starboard*". At 0816:45 (C-0:50) BURGAN's pilot orders "*Full hard to starboard*".
65. The helm of XPM was then put to midships in order to check her rate of turn to port, and her helm was then put hard to port at 0816:56 (C-0:39). At 0816:57 (C-0:36) BURGAN's pilot says "*Chowdhury Bhai, going Port to Port, you please come*".
66. On both videos there is about a 45 second gap between SS clearing BURGAN's starboard side and the collision, as also shown on the MADAS reconstruction.
